HEADQUARTERS STRATEGIC AIR COMMAND  
DIRECTORATE OF AIRCRAFT MAINTENANCE  
AIRCRAFT ENGINEERING DIVISION

⑨ ENGINEERING REPORT NO. P-313 ✓  
⑥ GIANT IMAGE II RELIABILITY AND MAINTAINABILITY  
(B-52D)  
⑪ 10 July 1978

ENGINEERING REPORT NO. P-286  
GIANT IMAGE RELIABILITY AND MAINTAINABILITY  
(B-52G/H)

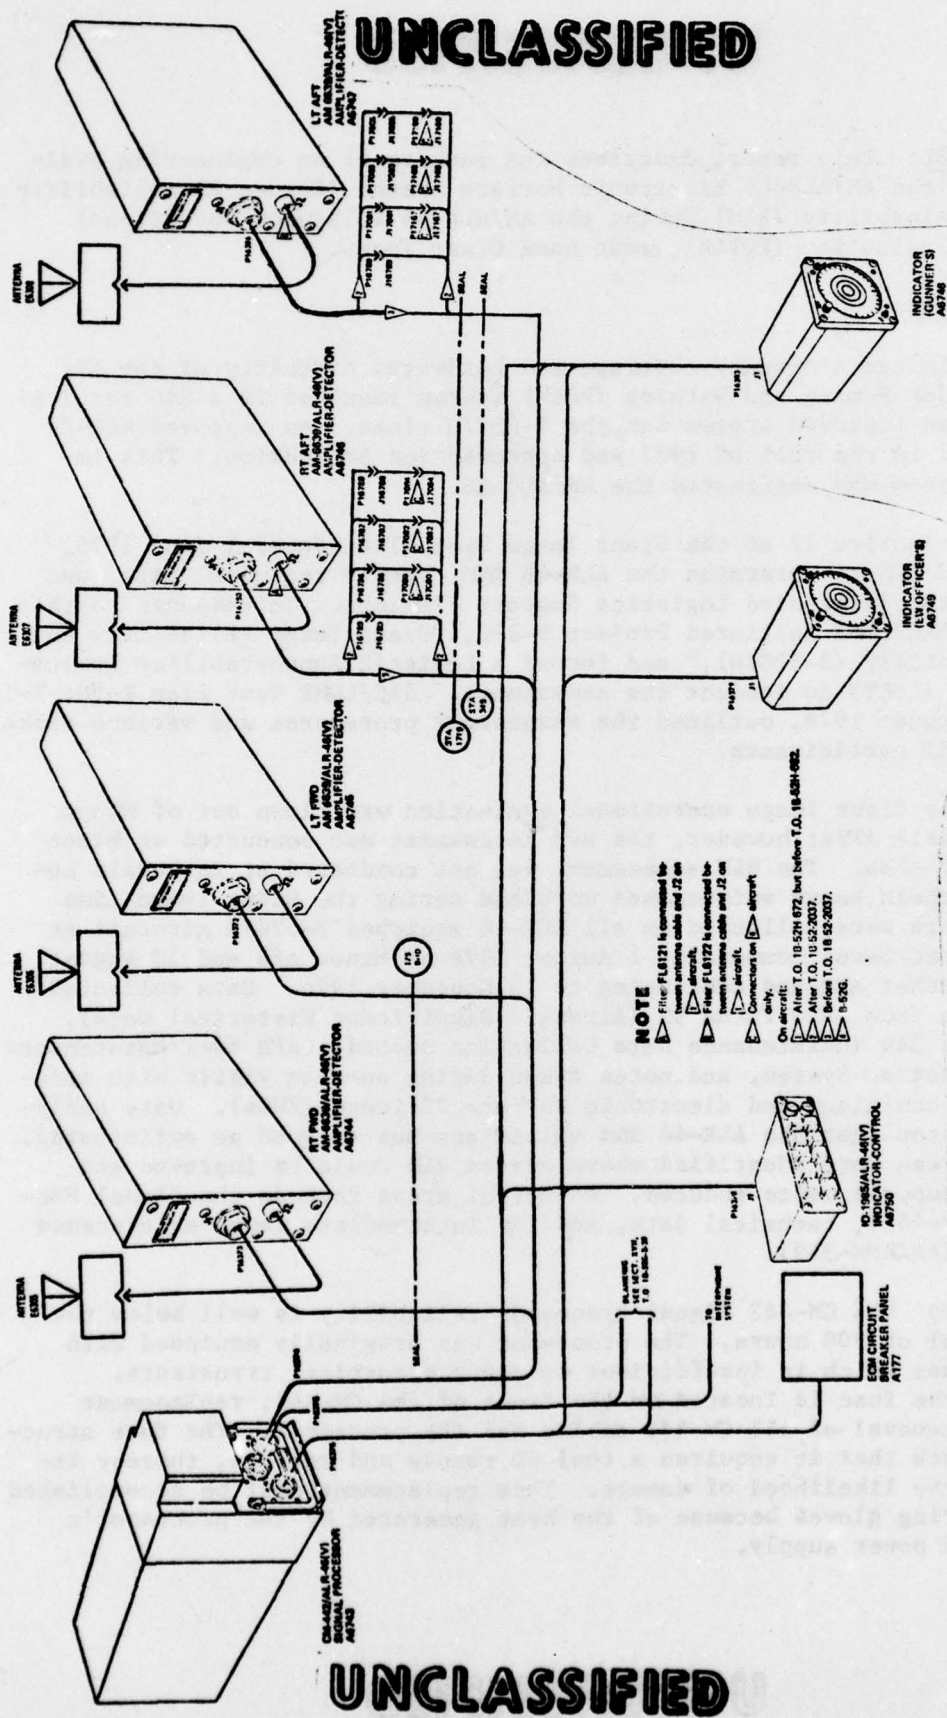
Figure 1 - AN/ALR-46 Electronic Warfare System

1. PURPOSE: This report describes the results of an engineering evaluation of the AN/ALR-46 Electronic Warfare System (Figure 1) reliability and maintainability (R&M) during the AN/ALR-46 Follow-on Operational Test and Evaluation (FOT&E), code name Giant Image.

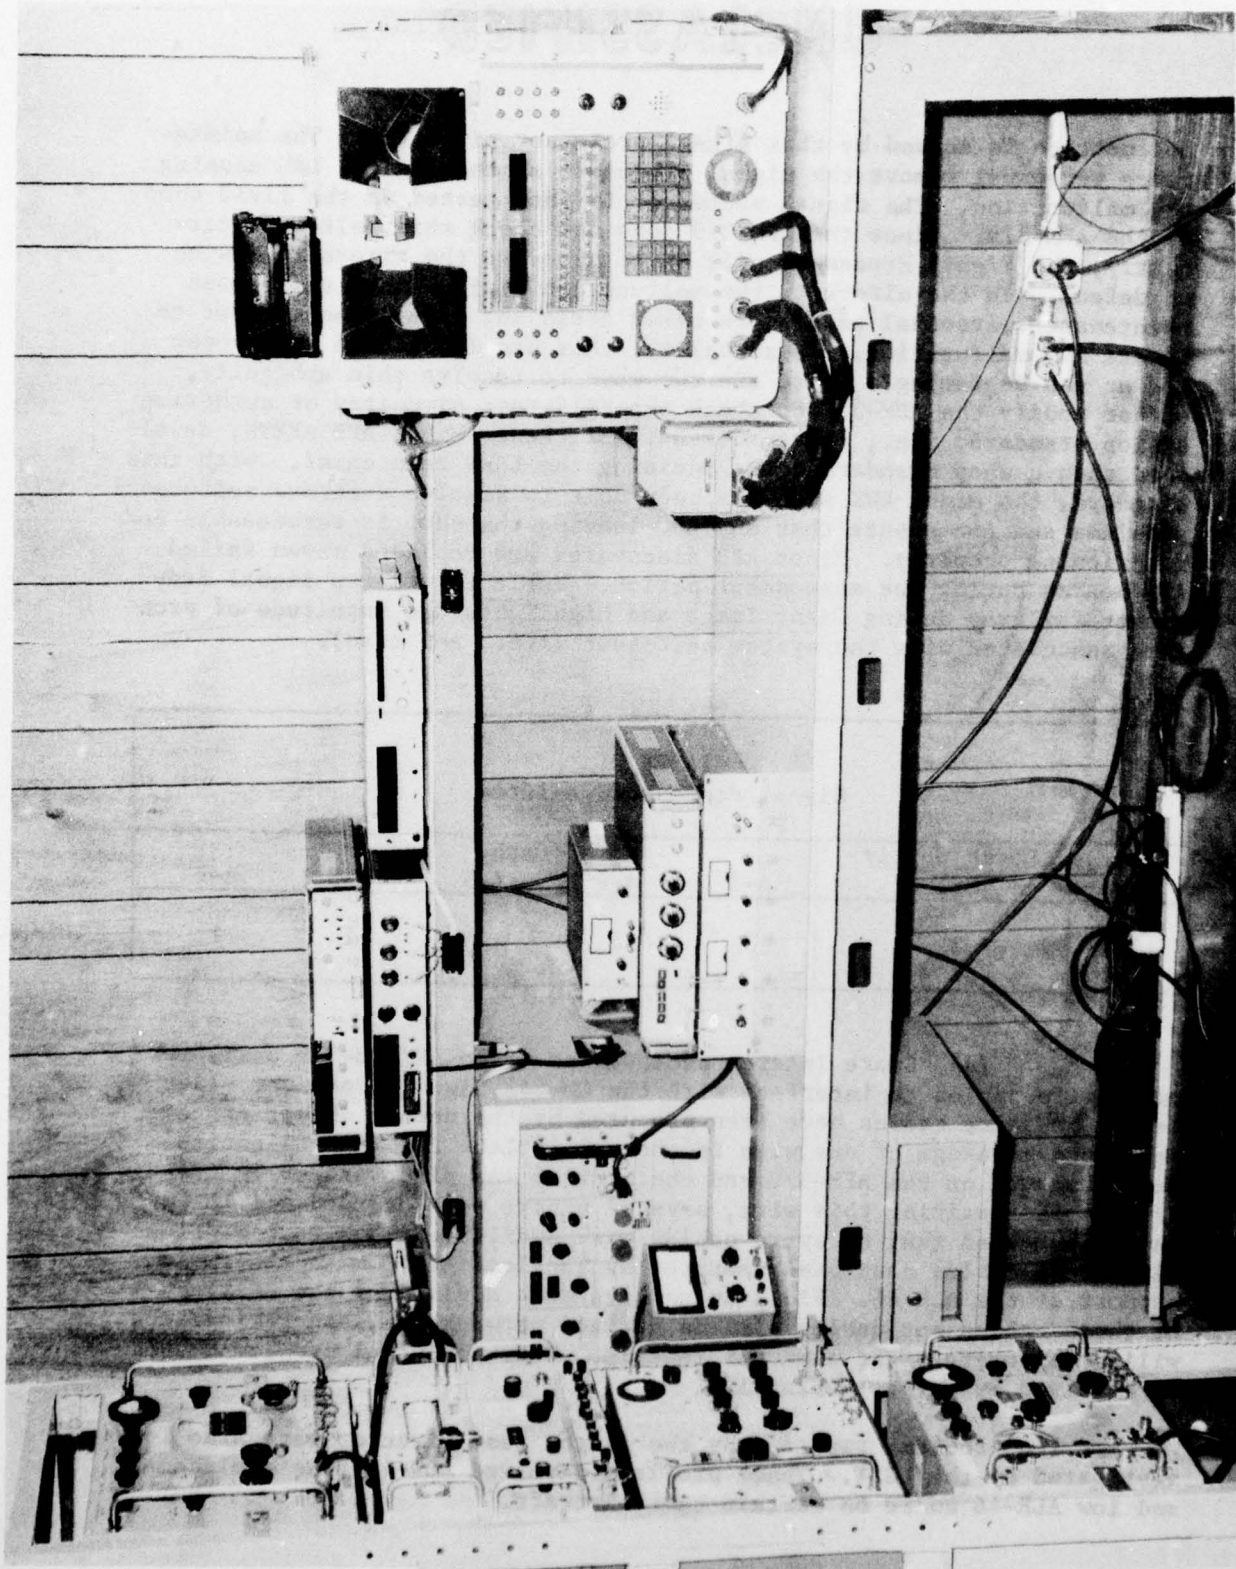
Figure 4 - Mather AFB AN/AIR-46 Work Area

j. The lack of a console or mounting racks for ALR-46 test equipment results in a potentially hazardous situation on the test bench. The scattered placement of equipment and connecting cables increases the possibility of the technician and equipment becoming entangled.

(a) Test Console - To properly connect the many needed items of test equipment, even where the equipment is logically mounted in a console, is difficult. To make these equipment inter-connections when the equipment is scattered throughout the work area, stacked one on top of the other, or even neatly arranged, is exceedingly difficult and subjects the equipment to damage from falling, incorrect electrical connections, or over-heating from poor air circulation. Figure 2 depicts a typical ALR-46 work bench, this one at Barksdale AFB. Mather AFB technicians have successfully resolved many problems by placing the RF signal generators in an equipment rack obtained from an old communications van (Figure 3). This rack can hold the five required RF signal generators (the fifth was out for calibration) in a safe secure manner, freeing the work bench for other required test equipment (Figure 4). A Form 1000 (No. MAT 051-77) has been submitted on this ALR-46 console set-up.

a. Recommend SAC/LGMA approve construction of an ALR-46 maintenance console.

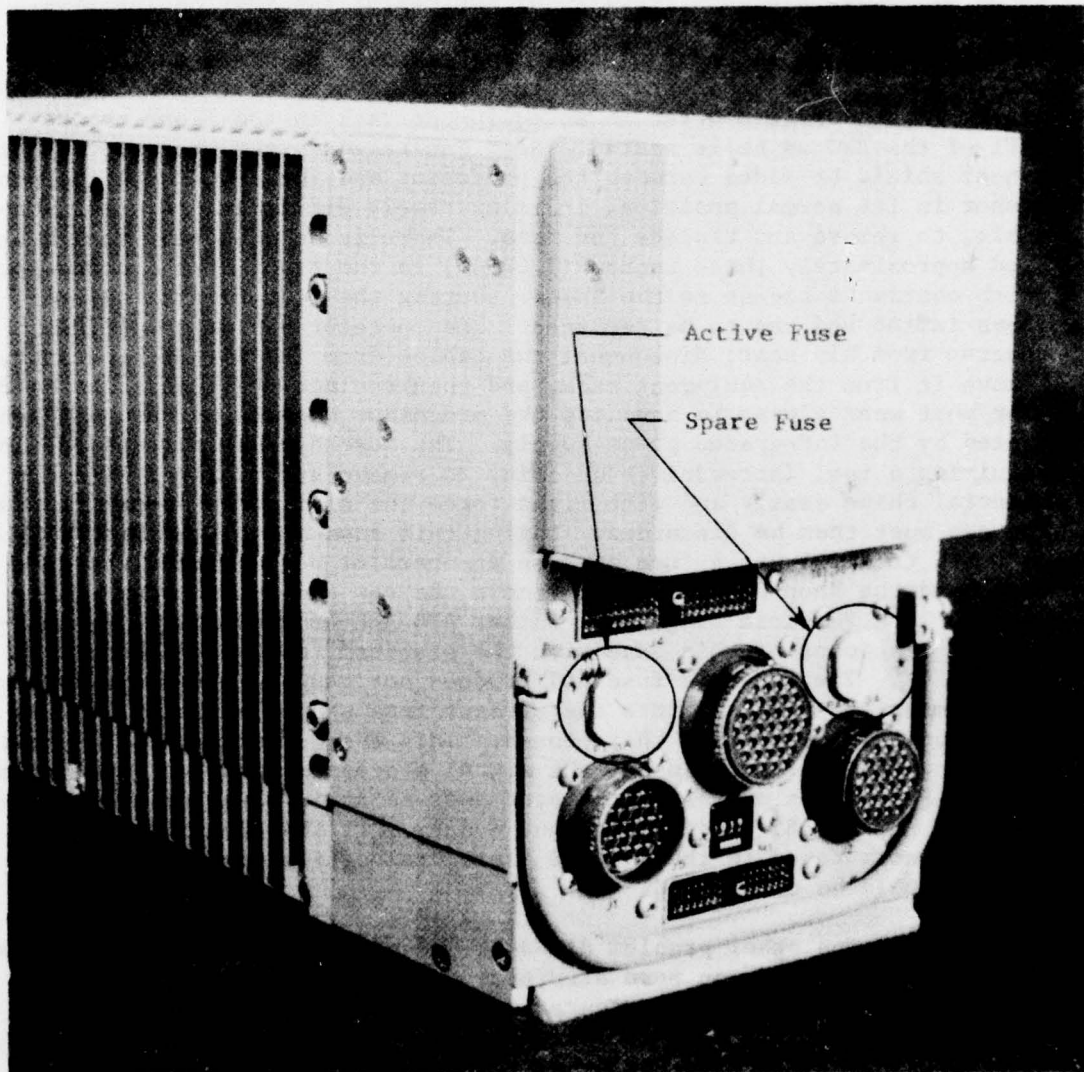
Figure 5 - AN/ALR-46 CM-442 Signal Processor

f. The processor fuse holder is extremely susceptible to damage during fuse removal and replacement.

(1) Fuse failures have been previously discussed and many of these problems have been resolved by increasing the fuse rating from 3-amps to 5-amps to handle electrical transients. However, the problem of removal and replacement of the fuse remains. The fuse and a spare are located on the lower front of the Signal Processor (Figure 5). The Signal Processor is mounted in an equipment rack on the floor to the left of the EWO as he is seated. Heat generated by the processor required a heat shield be added between the processor and the EWO. With the processor in its normal position, it is extremely difficult, if not impossible, to remove and replace the fuse. There is an equipment rack bulkhead approximately three inches (7.62 cm) to the front of the processor which obstructs access to the fuses. During the test flights several fuses failed and had to be replaced. The operator had to completely unstrap from his seat, disconnect the cables from the Signal Processor, remove it from the equipment rack, and then replace the fuse. The operator must wear gloves in handling the processor because of the heat generated by the integrated power supply. The fuse cap has a recessed slot requiring a tool (screwdriver or coin) to remove and replace. The cap material chips easily and with light force the slot edges become rounded. The cap must then be discarded. During this assessment, the Mather EWS shop had to drill out a fuse because an operator had stripped the slot edges and the shop was unable to remove the cap and fuse in any other manner. SrA Patricia Loegering, Mather AFB ALR-46 technician, investigated replacement of this fuse with the standard fuse and fuse holder, P/N FHN20G. The standard fuse holder does not require any tools for fuse replacement and will fit into the present fuse space. A Form 1000 has been submitted suggesting this change. This fuse and fuse holder would solve one operator problem but the signal processor location problem remains. Relocation of the signal processor is anticipated as part of the proposed AN/ALQ-155 Power Management System. If this system (ALQ-155) is not incorporated in the B-52G/H fleet, relocation of the Signal Processor should be considered.

(1) Take action to replace the present CM-442 fuse and fuse holder with the standard type fuse and fuse holder.

c. Recommend Oklahoma City ALC relocate the CM-442 processor to improve accessibility to the fuse and eliminate the need to remove the processor from the equipment rack for fuse replacement.

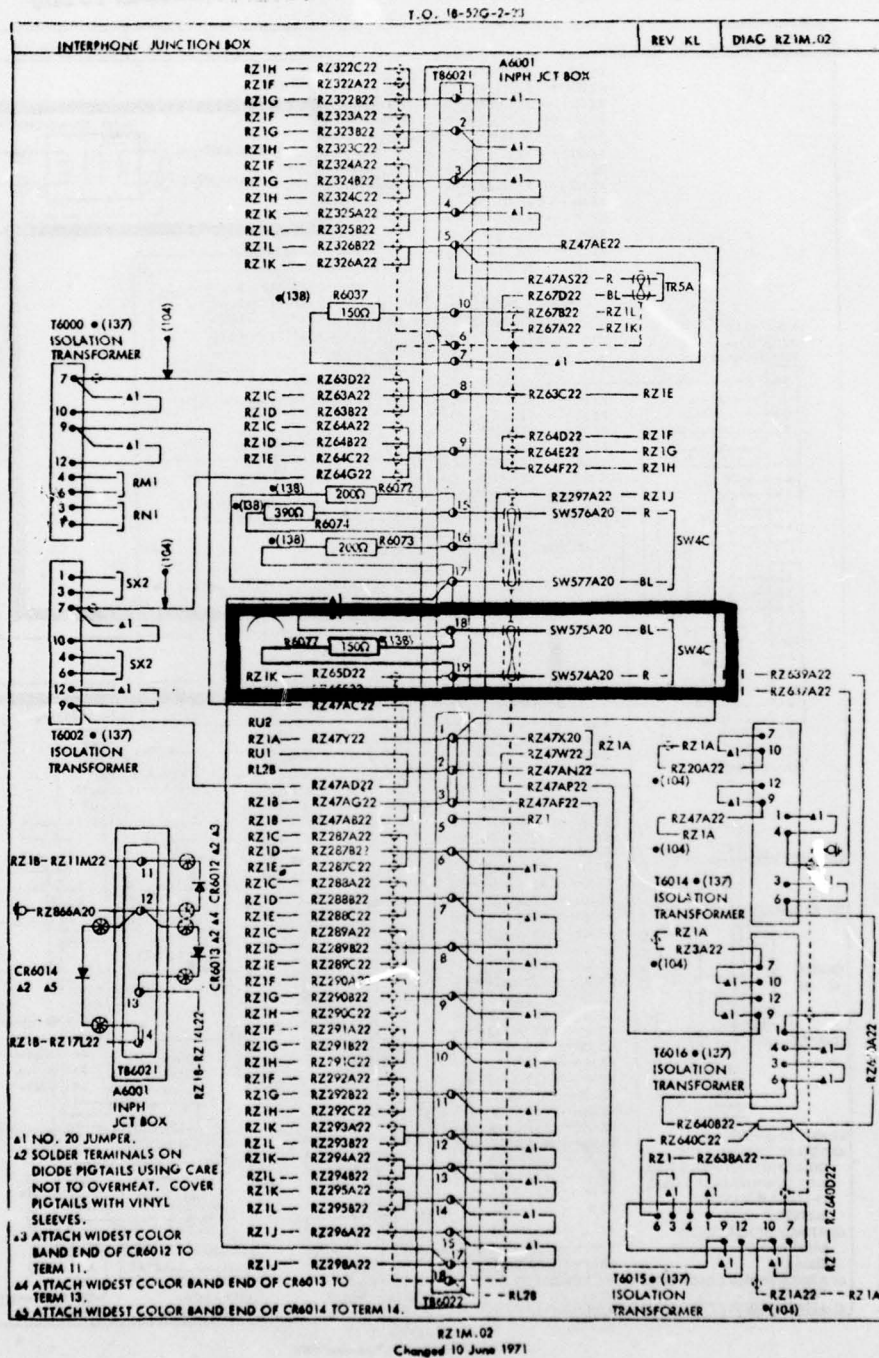
Figure 6 - B-52H Interphone Junction Box (Before TCTO 1B-52H-682)

g. Discrepancies in aircraft wiring contributed to poor ALR-46 audio performance.

terminals 18 and 19 (terminals 2 and 3 on TB6019 for B-52Gs) and resistor R6077 removed. Aircraft were found in three various configurations to include proper configuration with transformer installed and resistor removed, transformer installed and resistor not removed, and no transformer or resistor installed. These configurations were discovered at three bases after a telecon request for an inspection from the Giant Image LSET team chief. As a result, the SAC Deputy LGM requested all B-52G/H ALR-46 equipped units to conduct a one-time inspection to verify aircraft audio configurations and to bring them into compliance with applicable TCTOs. To date, six units have completed the inspection and have found seven aircraft improperly configured. The records of these seven aircraft reflected compliance with the applicable audio TCTOs. A significant improvement in ALR-46 audio was noted when the resistor R6077 was removed and the transformer installed.
